Pre-Demolition Environmental Inspection Summary Report

City of Royal Oak Township

Parcel Number:	2533360033	Inspected By:
Property Address:	20785 Westview Ave. Ferndale, MI 48220	J Wilhelmi September 25, 2018

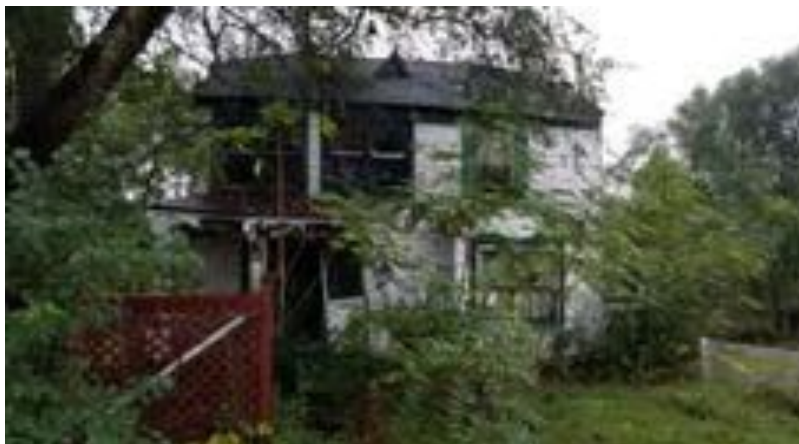
STRUCTURE OPEN TO ELEMENTS	CATEGORY 1 & 2 FRIABLE ACM PRESENT
COMPLETE BUILDING ACCESS	TIRES NOT PRESENT
2nd Floor waterlogged shaky floors

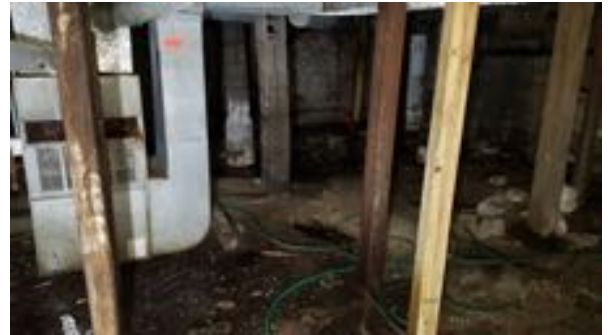
23

SUSPECT MATERIAM PLM SAMPLE

di1a

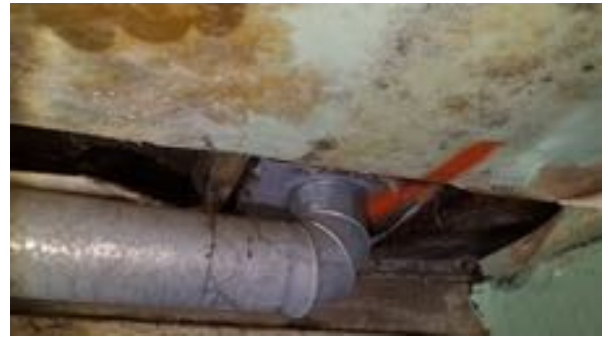
24

SUSPECT MATERIAM PLM SAMPLE

dw1b c

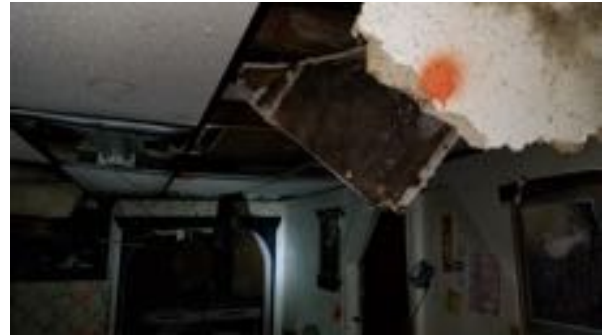
SUSPECT MATERIAM PLM SAMPLE
ct1a b

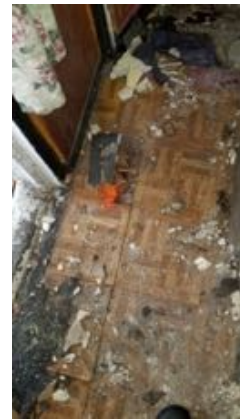
9

SUSPECT MATERIAM PLM SAMPLE
ft1a

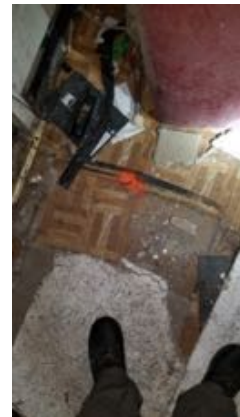
10

SUSPECT MATERIAM PLM SAMPLE
ft1b

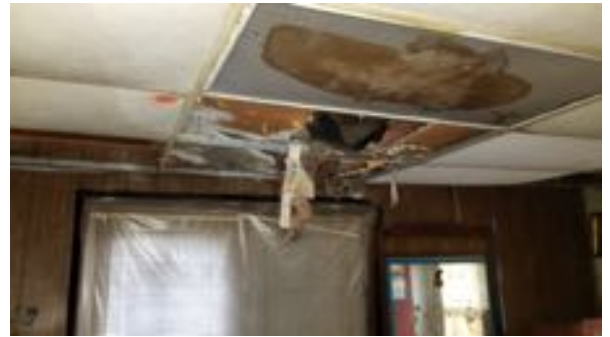
SUSPECT MATERIAM PLM SAMPLE

ct2a b

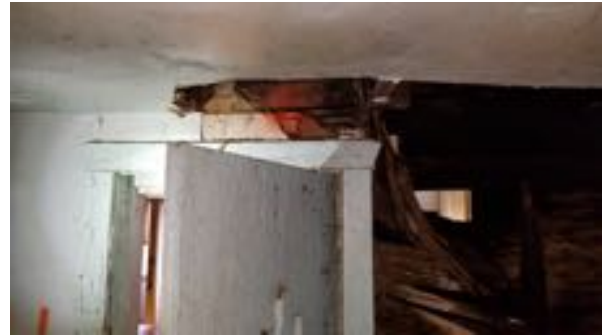
SUSPECT MATERIAM PLM SAMPLE

pl1c

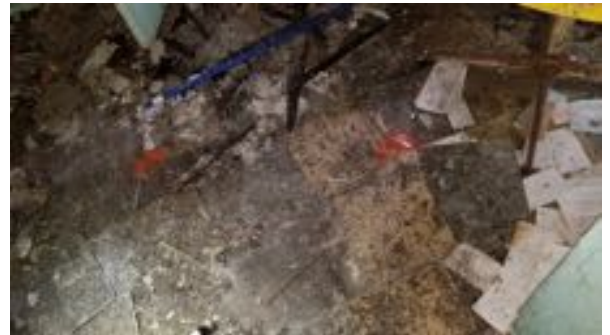
18

SUSPECT MATERIAM PLM SAMPLE

ft4a b

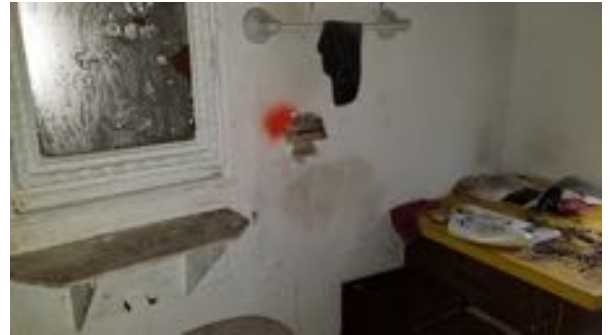
SUSPECT MATERIAM PLM SAMPLE

p11b

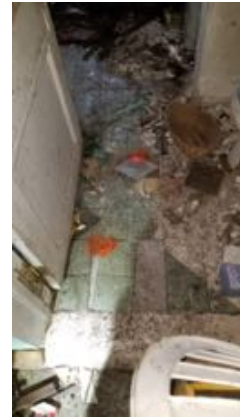
20

SUSPECT MATERIAM PLM SAMPLE

ft5a b

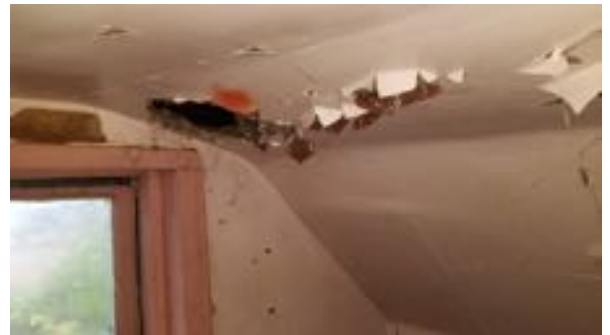
SUSPECT MATERIAM PLM SAMPLE

pl1g
