**Pre-Demolition Environmental Inspection Summary Report**

**City of Royal Oak Township**

<b>Parcel Number:</b>	<b>2533327012</b>	<b>Inspected By:</b>
<b>Property Address:</b>	<b>21332 Westview Ave. Ferndale, MI 48220</b>	<b>J Wilhelmi September 25, 2018</b>

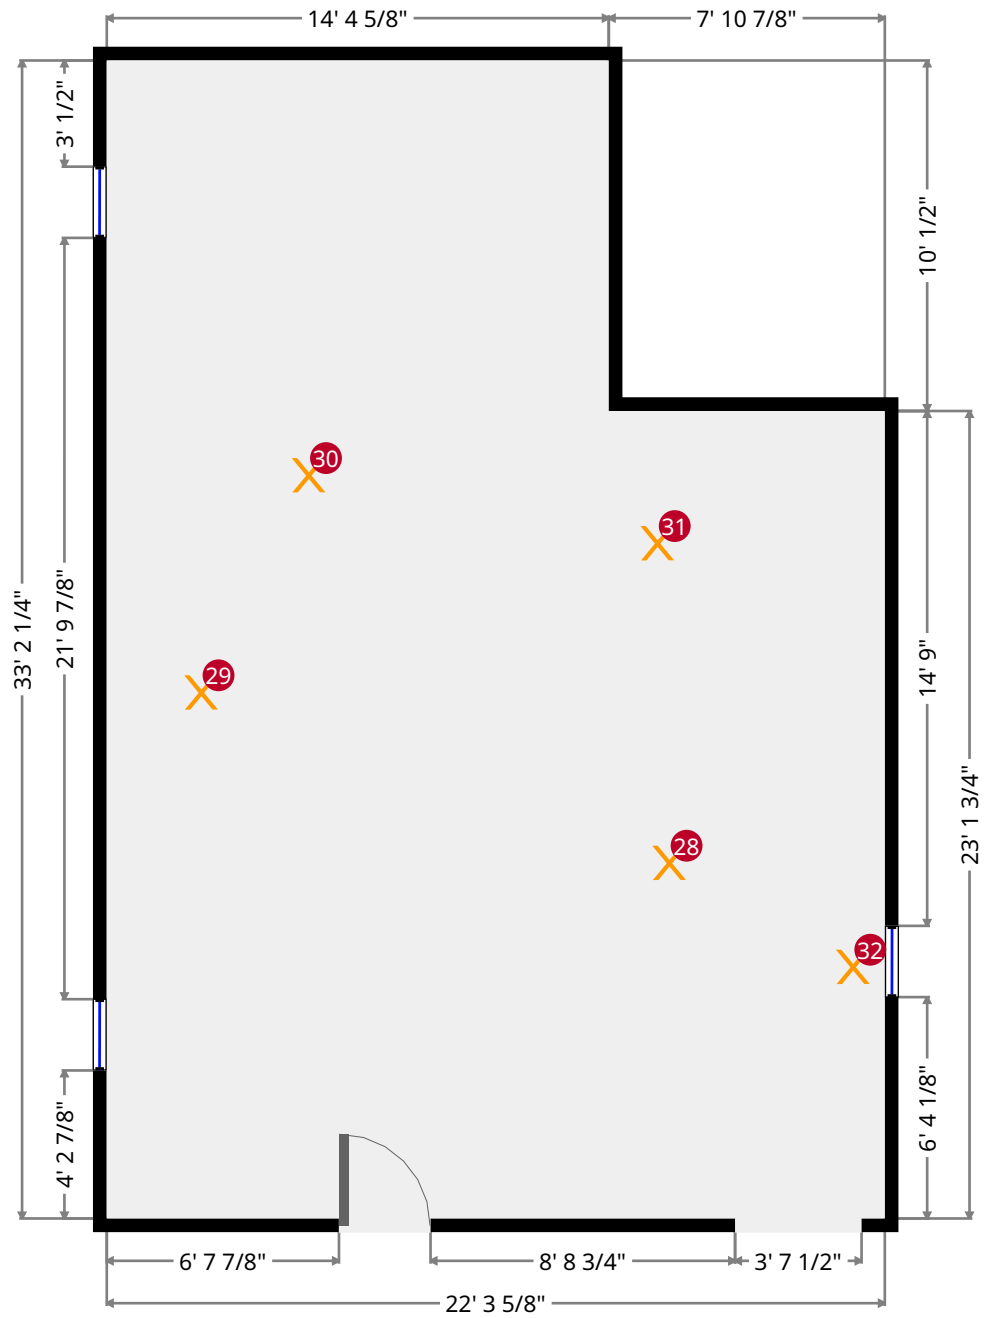
20

Width: 22' 3 5/8"  
Length: 33' 2 1/4"  
Area: 660.52 sq ft  
Perimeter: 110' 11 5/8"

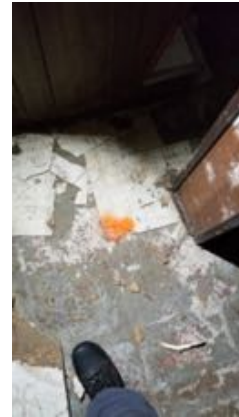
SUSPECT MATERIAM PLM SAMPLE

ft12a

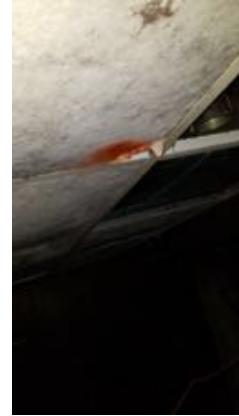
SUSPECT MATERIAM PLM SAMPLE  
ct1a

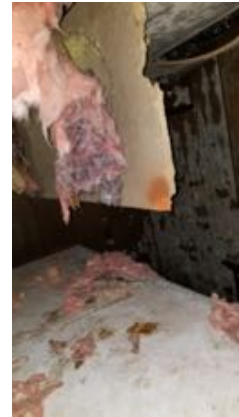
SUSPECT MATERIAM PLM SAMPLE  
ct1b

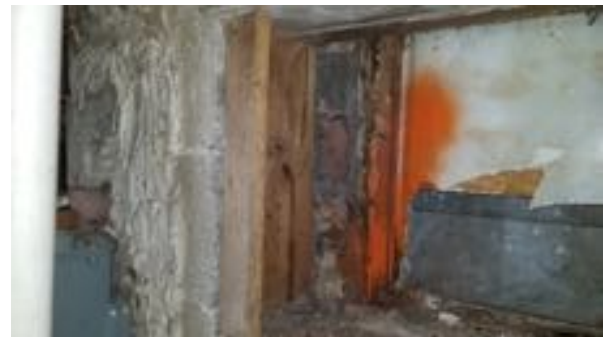
SUSPECT MATERIAM PLM SAMPLE  
wg1a b

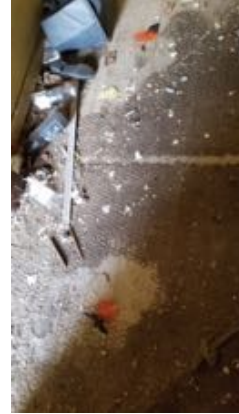
SUSPECT MATERIAM PLM SAMPLE

ft1a b

Sample Information	Asbestos Type/Percent	Non-Asbestos Material
Lab ID #: 80005 - 01 Cust. #: FT 1A Material: Floor Tile 9"x9" Location: FS 1 Appearance: beige, fibrous, homogenous Layer: 1 of 2	Asbestos Present: <b>YES</b> Chrysotile - 5%	Other - 95%
Lab ID #: 80005 - 01a Cust. #: FT 1A Material: Mastic Location: FS 1 Appearance: black, nonfibrous, homogenous Layer: 2 of 2	Asbestos Present: <b>NO</b> No Asbestos Observed	Other - 100%
Lab ID #: 80005 - 02 Cust. #: FT 1B Material: Floor Tile 9"x9" Location: FS 1 Appearance: Layer: 1 of 2	Asbestos Present:  NOT ANALYZED

Sample Information	Asbestos Type/Percent	Non-Asbestos Material
Lab ID #: 80005 - 02a Cust. #: FT 1B Material: Mastic Location: FS 1 Appearance: black,nonfibrous,homogenous Layer: 2 of 2	Asbestos Present: <b>NO</b> No Asbestos Observed	Other - 100%
Lab ID #: 80005 - 03 Cust. #: FT 2A Material: Floor Tile 9"x9" Location: FS 1A Appearance: red,fibrous,homogenous Layer: 1 of 2	Asbestos Present: <b>YES</b> Chrysotile - 10%	Other - 90%
Lab ID #: 80005 - 03a Cust. #: FT 2A Material: Mastic Location: FS 1A Appearance: black,nonfibrous,homogenous Layer: 2 of 2	Asbestos Present: <b>NO</b> No Asbestos Observed	Other - 100%

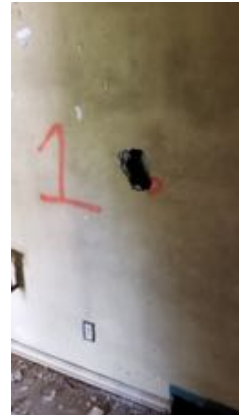
SUSPECT MATERIAM PLM SAMPLE

pl1a

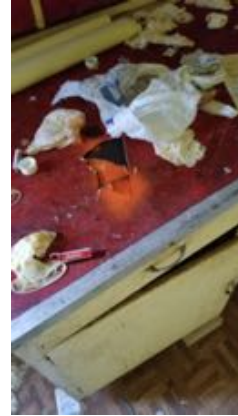
SUSPECT MATERIAM PLM SAMPLE  
ft2a b

Sample Information	Asbestos Type/Percent	Non-Asbestos Material
Lab ID #: 80005 - 04 Cust. #: FT 2B Material: Floor Tile 9"x9" Location: FS 1A Appearance: Layer: 1 of 2	Asbestos Present:  NOT ANALYZED	
Lab ID #: 80005 - 04a Cust. #: FT 2B Material: Mastic Location: FS 1A Appearance: black,nonfibrous,homogenous Layer: 2 of 2	Asbestos Present: <b>NO</b> No Asbestos Observed	Other - 100%
Lab ID #: 80005 - 05 Cust. #: FT 3A Material: Floor Tile 9"x9" Location: FS 5 Appearance: green,fibrous,homogenous Layer: 1 of 4	Asbestos Present: <b>YES</b> Chrysotile - 5%	Other - 95%

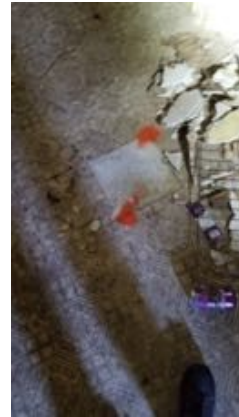
ft4a b

SUSPECT MATERIAM PLM SAMPLE

Sample Information	Asbestos Type/Percent	Non-Asbestos Material
Lab ID #: 80005 - 07b Cust. #: FT 4A Material: Cream Floor Tile Location: FS 7 Appearance: white, fibrous, homogenous Layer: 3 of 4	Asbestos Present: <b>YES</b> Chrysotile - 5%	Other - 95%
Lab ID #: 80005 - 07c Cust. #: FT 4A Material: Glue Location: FS 7 Appearance: yellow, nonfibrous, homogenous Layer: 4 of 4	Asbestos Present: <b>NO</b> No Asbestos Observed	Other - 100%
Lab ID #: 80005 - 08 Cust. #: FT 4B Material: Floor Tile 12"x12" Location: FS 7 Appearance: Layer: 1 of 4	Asbestos Present:  NOT ANALYZED

Sample Information	Asbestos Type/Percent	Non-Asbestos Material
Lab ID #: 80005 - 08a Cust. #: FT 4B Material: Glue Location: FS 7 Appearance: yellow,nonfibrous,homogenous Layer: 2 of 4	Asbestos Present: <b>NO</b> No Asbestos Observed	Other - 100%
Lab ID #: 80005 - 08b Cust. #: FT 4B Material: Cream Floor Tile Location: FS 7 Appearance: Layer: 3 of 4	Asbestos Present:  NOT ANALYZED	
Lab ID #: 80005 - 08c Cust. #: FT 4B Material: Glue Location: FS 7 Appearance: yellow,nonfibrous,homogenous Layer: 4 of 4	Asbestos Present: <b>NO</b> No Asbestos Observed	Other - 100%

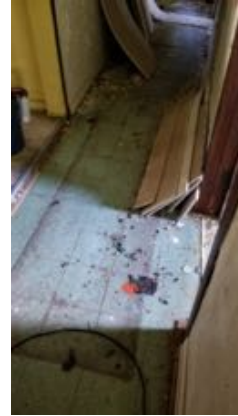
ft3a b

SUSPECT MATERIAM PLM SAMPLE

Sample Information	Asbestos Type/Percent	Non-Asbestos Material
Lab ID #: 80005 - 05a Cust. #: FT 3A Material: Mastic Location: FS 5 Appearance: black,nonfibrous,homogenous Layer: 2 of 4	Asbestos Present: <b>NO</b> No Asbestos Observed	Other - 100%
Lab ID #: 80005 - 05b Cust. #: FT 3B Material: Red Floor Tile Location: FS 5 Appearance: red,fibrous,homogenous Layer: 3 of 4	Asbestos Present: <b>YES</b> Chrysotile - 10%	Other - 90%
Lab ID #: 80005 - 05c Cust. #: FT 3A Material: Mastic Location: FS 5 Appearance: black,nonfibrous,homogenous Layer: 4 of 4	Asbestos Present: <b>NO</b> No Asbestos Observed	Other - 100%

Sample Information	Asbestos Type/Percent	Non-Asbestos Material
Lab ID #: 80005 - 06 Cust. #: FT 3B Material: Floor Tile 9"x9" Location: FS 5 Appearance: Layer: 1 of 4	Asbestos Present:  NOT ANALYZED	
Lab ID #: 80005 - 06a Cust. #: FT 3B Material: Mastic Location: FS 5 Appearance: black,nonfibrous,homogenous Layer: 2 of 4	Asbestos Present: <b>NO</b> No Asbestos Observed	Other - 100%
Lab ID #: 80005 - 06b Cust. #: FT 3B Material: Red Floor Tile Location: FS 5 Appearance: Layer: 3 of 4	Asbestos Present:  NOT ANALYZED

Sample Information	Asbestos Type/Percent	Non-Asbestos Material
Lab ID #: 80005 - 06c Cust. #: FT 3B Material: Mastic Location: FS 5 Appearance: black,nonfibrous,homogenous Layer: 4 of 4	Asbestos Present: <b>NO</b> No Asbestos Observed	Other - 100%
Lab ID #: 80005 - 07 Cust. #: FT 4A Material: Floor Tile 12"x12" Location: FS 7 Appearance: beige,fibrous,homogenous Layer: 1 of 4	Asbestos Present: <b>YES</b> Chrysotile - 5%	Other - 95%
Lab ID #: 80005 - 07a Cust. #: FT 4A Material: Glue Location: FS 7 Appearance: yellow,nonfibrous,homogenous Layer: 2 of 4	Asbestos Present: <b>NO</b> No Asbestos Observed	Other - 100%

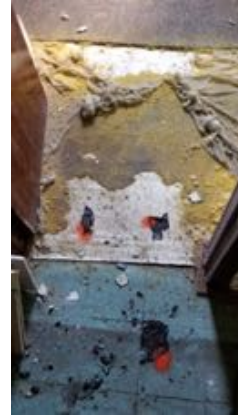
I2a b

SUSPECT MATERIAL PLM SAMPLE

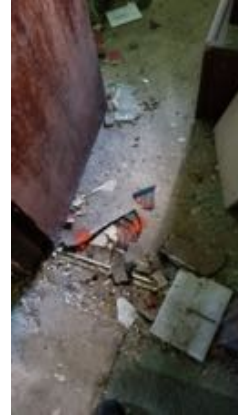
I4a b

SUSPECT MATERIAL PLM SAMPLE

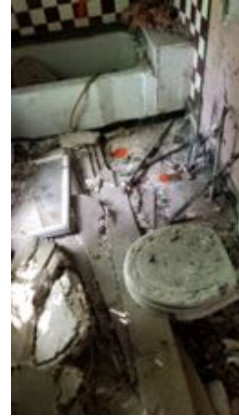
ft5a b

SUSPECT MATERIAM PLM SAMPLE

Sample Information	Asbestos Type/Percent	Non-Asbestos Material
Lab ID #: 80005 - 09 Cust. #: FT 5A Material: Floor Tile 12"x12" Location: FS 9 Appearance: beige, fibrous, homogenous Layer: 1 of 4	Asbestos Present: <b>YES</b> Chrysotile - 5%	Other - 95%
Lab ID #: 80005 - 09a Cust. #: FT 5A Material: Glue Location: FS 9 Appearance: yellow, nonfibrous, homogenous Layer: 2 of 4	Asbestos Present: <b>NO</b> No Asbestos Observed	Other - 100%
Lab ID #: 80005 - 09b Cust. #: FT 5A Material: Green Floor Tile Location: FS 9 Appearance: green, fibrous, homogenous Layer: 3 of 4	Asbestos Present: <b>YES</b> Chrysotile - 5%	Other - 95%

Sample Information	Asbestos Type/Percent	Non-Asbestos Material
Lab ID #: 80005 - 09c Cust. #: FT 5A Material: Glue Location: FS 9 Appearance: black,nonfibrous,homogenous Layer: 4 of 4	Asbestos Present: <b>NO</b> No Asbestos Observed	Other - 100%
Lab ID #: 80005 - 10 Cust. #: FT 5B Material: Floor Tile 12"x12" Location: FS 9 Appearance: Layer: 1 of 4	Asbestos Present:  NOT ANALYZED	
Lab ID #: 80005 - 10a Cust. #: FT 5B Material: Glue Location: FS 9 Appearance: yellow,nonfibrous,homogenous Layer: 2 of 4	Asbestos Present: <b>NO</b> No Asbestos Observed	Other - 100%

Sample Information	Asbestos Type/Percent	Non-Asbestos Material
Lab ID #: 80005 - 10b Cust. #: FT 5B Material: Green Floor Tile Location: FS 9 Appearance: Layer: 3 of 4	Asbestos Present:  NOT ANALYZED	
Lab ID #: 80005 - 10c Cust. #: FT 5B Material: Glue Location: FS 9 Appearance: black,nonfibrous,homogenous Layer: 4 of 4	Asbestos Present: <b>NO</b> No Asbestos Observed	Other - 100%
Lab ID #: 80005 - 11 Cust. #: FT 6A Material: Floor Tile 12"x12" Location: FS 10 Appearance: white,fibrous,homogenous Layer: 1 of 4	Asbestos Present: <b>YES</b> Chrysotile - 5%	Other - 95%

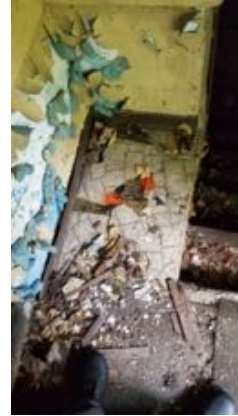
ft6a b

SUSPECT MATERIAL PLM SAMPLE

Sample Information	Asbestos Type/Percent	Non-Asbestos Material
Lab ID #: 80005 - 11a Cust. #: FT 6A Material: Glue Location: FS 10 Appearance: yellow,nonfibrous,homogenous Layer: 2 of 4	Asbestos Present: <b>NO</b> No Asbestos Observed	Other - 100%
Lab ID #: 80005 - 11b Cust. #: FT 6A Material: Black Floor Tile Location: FS 10 Appearance: black,fibrous,homogenous Layer: 3 of 4	Asbestos Present: <b>YES</b> Chrysotile - 10%	Other - 90%
Lab ID #: 80005 - 11c Cust. #: FT 6A Material: Mastic Location: FS 10 Appearance: black,nonfibrous,homogenous Layer: 4 of 4	Asbestos Present: <b>YES</b> Chrysotile - 10%	Other - 90%

Sample Information	Asbestos Type/Percent	Non-Asbestos Material
Lab ID #: 80005 - 12 Cust. #: FT 6B Material: Floor Tile 12"x12" Location: FS 10 Appearance: Layer: 1 of 4	Asbestos Present:  NOT ANALYZED	
Lab ID #: 80005 - 12a Cust. #: FT 6B Material: Glue Location: FS 10 Appearance: yellow,nonfibrous,homogenous Layer: 2 of 4	Asbestos Present: <b>NO</b> No Asbestos Observed	Other - 100%
Lab ID #: 80005 - 12b Cust. #: FT 6B Material: Black Floor Tile Location: FS 10 Appearance: Layer: 3 of 4	Asbestos Present:  NOT ANALYZED

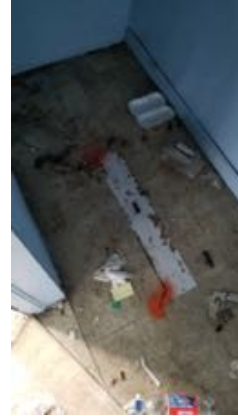
SUSPECT MATERIAM PLM SAMPLE  
ft9ab

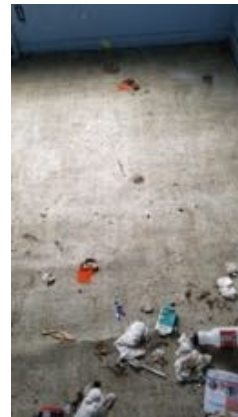
SUSPECT MATERIAM PLM SAMPLE  
ft5a b

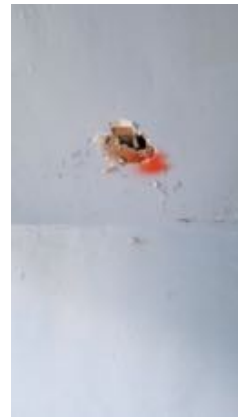
SUSPECT MATERIAM PLM SAMPLE  
pl1f

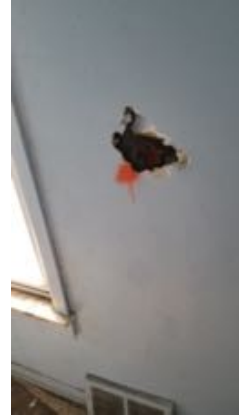
pl1g

SUSPECT MATERIAM PLM SAMPLE

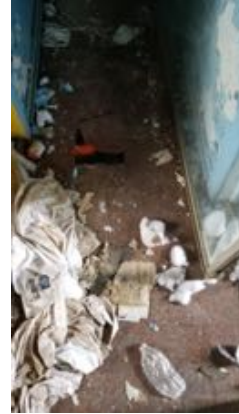
SUSPECT MATERIAM PLM SAMPLE  
ft7a

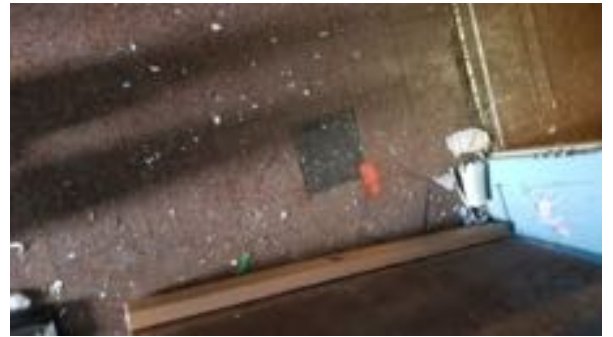
SUSPECT MATERIAM PLM SAMPLE  
ft7b

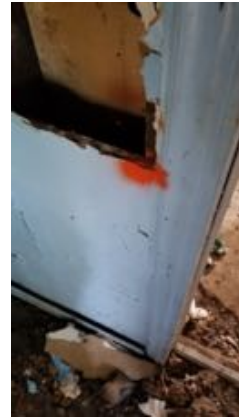
SUSPECT MATERIAM PLM SAMPLE  
dw1b

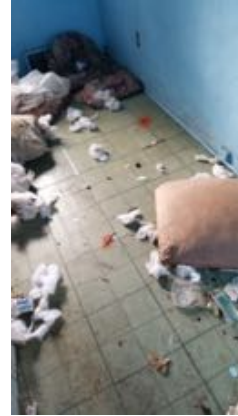
ft10a b

SUSPECT MATERIAL PLM SAMPLE

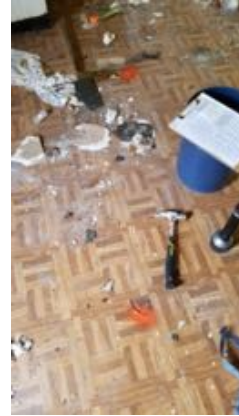
SUSPECT MATERIAM PLM SAMPLE  
ft8a b

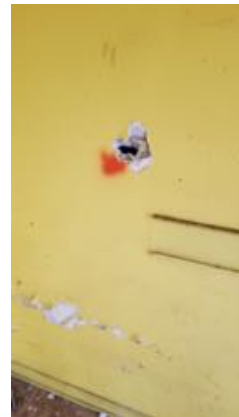
SUSPECT MATERIAM PLM SAMPLE  
pl1e

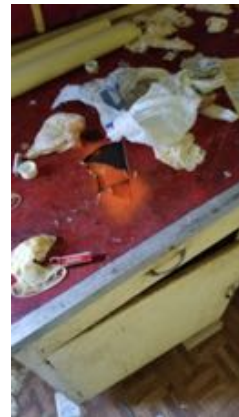
SUSPECT MATERIAM PLM SAMPLE  
l6a b

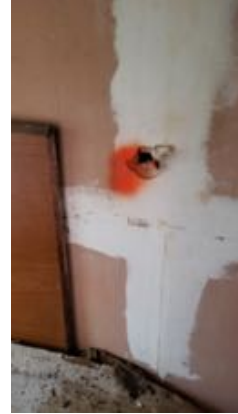
dw1a

SUSPECT MATERIAM PLM SAMPLE
