Pre-Demolition Environmental Inspection Summary Report

City of Royal Oak Township

Parcel Number:	2533360033	Inspected By:
Property Address:	20785 Westview Ave. Ferndale, MI 48220	J Wilhelmi September 25, 2018

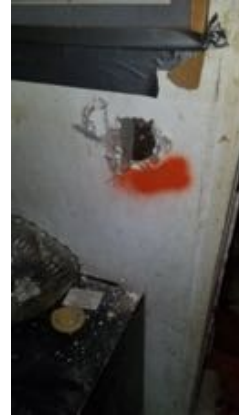
dw1a

SUSPECT MATERIAM PLM SAMPLE

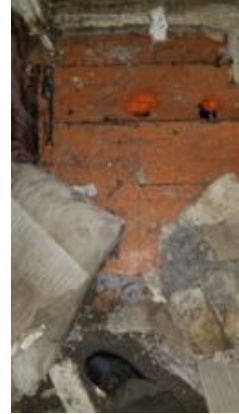
ft1a b

SUSPECT MATERIAM PLM SAMPLE

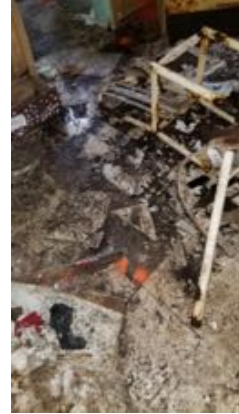
ft3a b

SUSPECT MATERIAM PLM SAMPLE

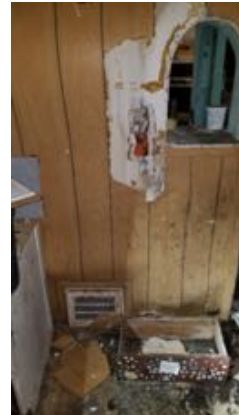
pl1a

SUSPECT MATERIAM PLM SAMPLE

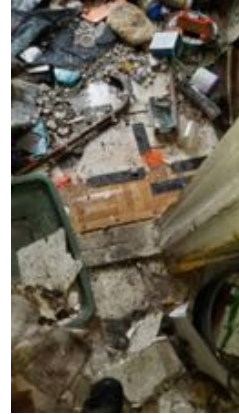
ft6a b

SUSPECT MATERIAL PLM SAMPLE

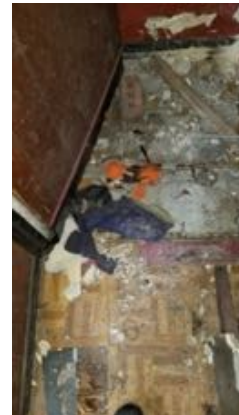
ft7a b

SUSPECT MATERIAL PLM SAMPLE

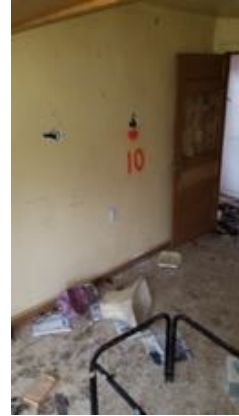
p11d

SUSPECT MATERIAM PLM SAMPLE

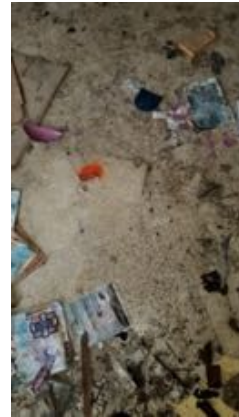
ft8a b

SUSPECT MATERIAM PLM SAMPLE

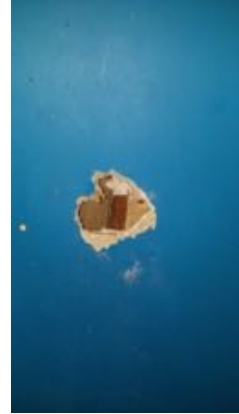
pl1f

SUSPECT MATERIAM PLM SAMPLE

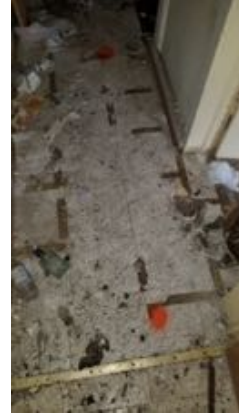
ft9a b

SUSPECT MATERIAL PLM SAMPLE
